AMISTAD NATIONAL RECREATION AREA,

**WATER RESOURCES SCOPING REPORT**

**Technical Report NPS/NRWRD/NRTR-2001/295**

September, 2001

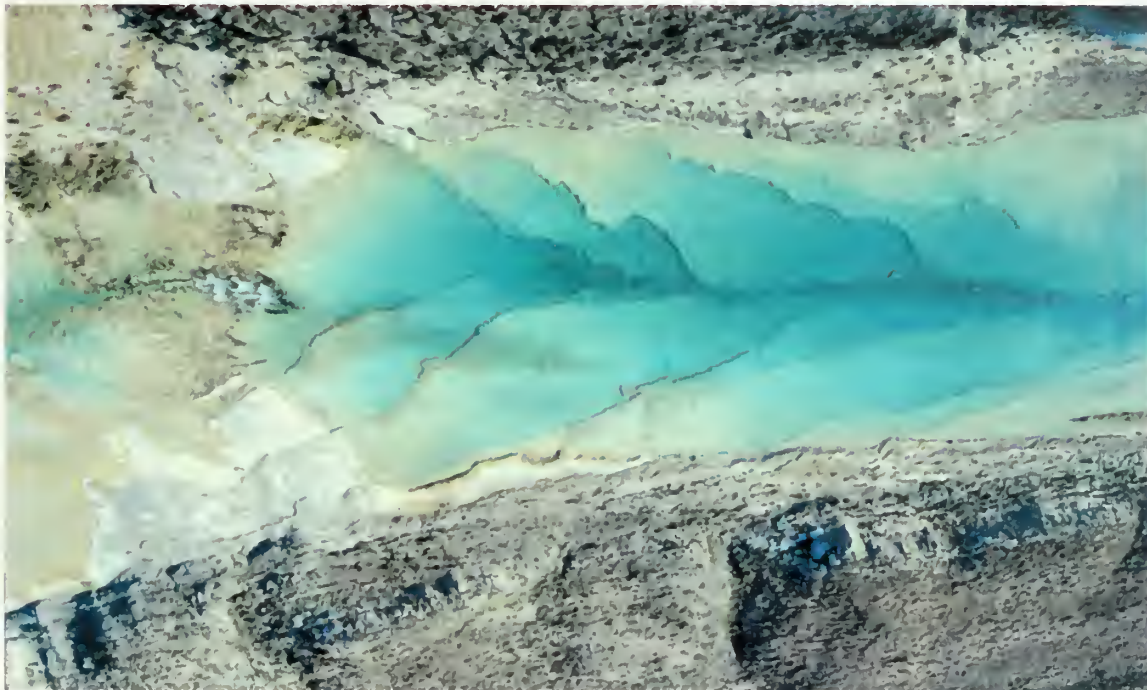
**Figure 6. Aerial Close up of Devils River Channel**

The Devils River flows over a base structure of limestone shelves, forming swift narrow runs alternating with calm braided channels and slow flowing pools (Figure 6). Pecan, oak and sycamore are found along the riverbanks (Figure 7). Salt cedar has not become a nuisance exotic species in this system, due to the semi-annual high flows, which scour shorelines and benefit native plant regeneration.

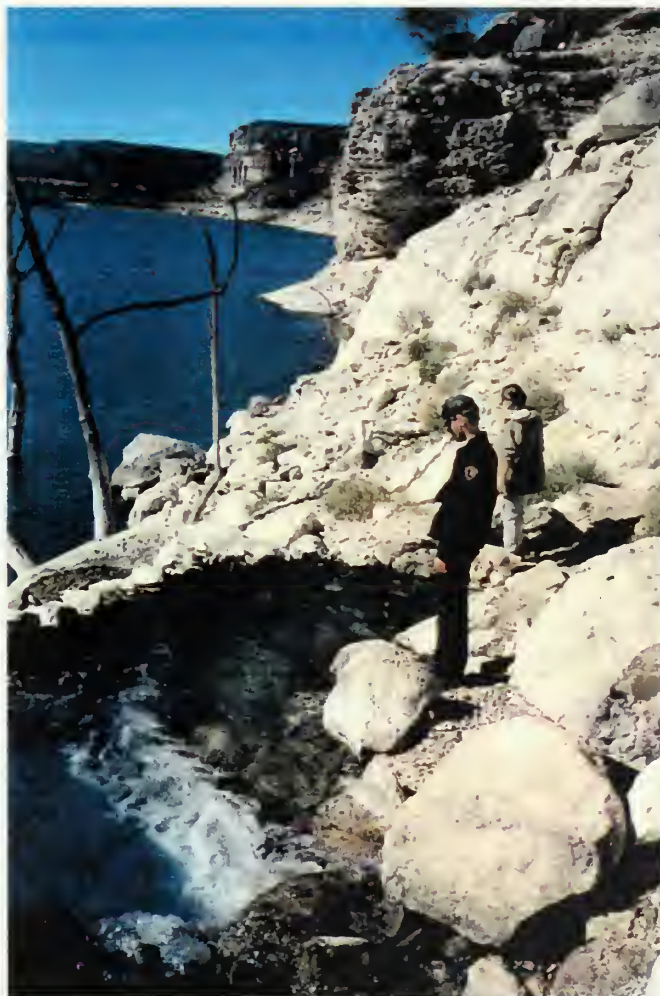
**Figure 8. Indian Springs**

The Devils River has one of the largest base flows of Texas rivers due to spring flow (Brune, 1981), and a few springs, such as Willow Springs and Indian Springs are still visible depending on water level (Figure 8). Historic springs noted in the Devils River watershed include: Juno, Headwater, or Stein Springs (originally two springs; dry in 1971, Pecan Springs (originally 6 springs; only one flowing in 1971), Hudspeth Springs (many springs; still flowing in 1971), Finegan Springs (originally 25 springs; nine remain flowing in 1971), Dolan Springs (two main and 20 smaller springs continue flowing in 1971), Gillis Springs (about 14 springs, some below river level, still flowing in 1971).

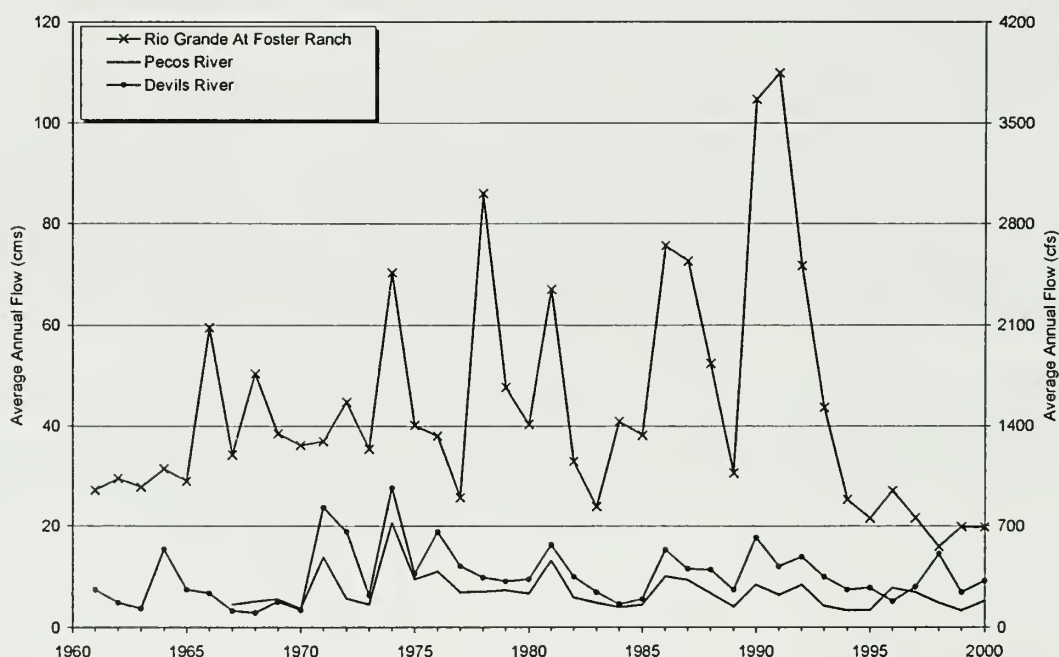
**Figure 1. Annual Mean Flow of the Major Tributaries to Amistad Reservoir.**

Flow from the Rio Grande (Rio Bravo), Pecos River and the Devils River; account for more than 70% of the estimated inflows to Amistad Reservoir. The remaining third of reservoir inflows are contributed primarily from springs, the largest being Goodenough Spring, which was inundated when the reservoir filled. Early streamflow records show that Goodenough Spring averaged almost 62,000 cubic feet per second (cfs) (1,750 cubic meters per second (cms)). Other springs are located along the Devils River below the gauging station and around the circumference of the reservoir as described in the previous section. In response to localized rainstorms, several ungauged Mexican arroyos also flow into the reservoir.

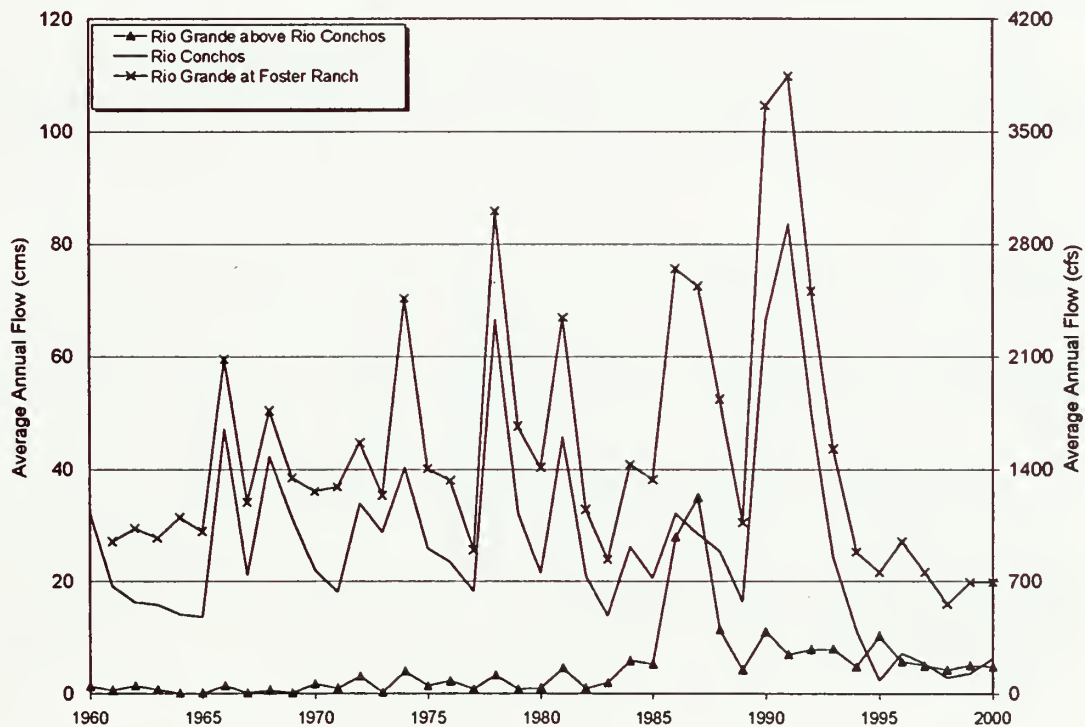
**Figure 10. Average annual flows of the Rio Conchos, Rio Grande above the Rio Conchos and Rio Grande at Foster Ranch (just above Amistad Reservoir).**

Two rivers come together to form the Rio Grande above Amistad NRA. The Upper Rio Grande originates from the Rocky Mountains in Colorado and New Mexico and the Rio Conchos flows from the Sierra Madres of Western Chihuahua, Mexico. The two rivers join at Ojinaga, Chihuahua and Presidio, Texas, about 60 miles (97 km) upstream from Big Bend National Park. The flow from these rivers accounts for over two-thirds of Rio Grande flow entering Amistad Reservoir. Until 1993, the majority of the flow into the reservoir from the Rio Grande came from the Rio Conchos (Figure 10). However, below average precipitation and increased water use in the Rio Conchos Basin have decreased the flow from this river. Other sources of water into the Rio Grande include many springs along the limestone canyons above the reservoir and the arroyos, which flow in response to rainstorms along this isolated stretch of the Rio Grande.

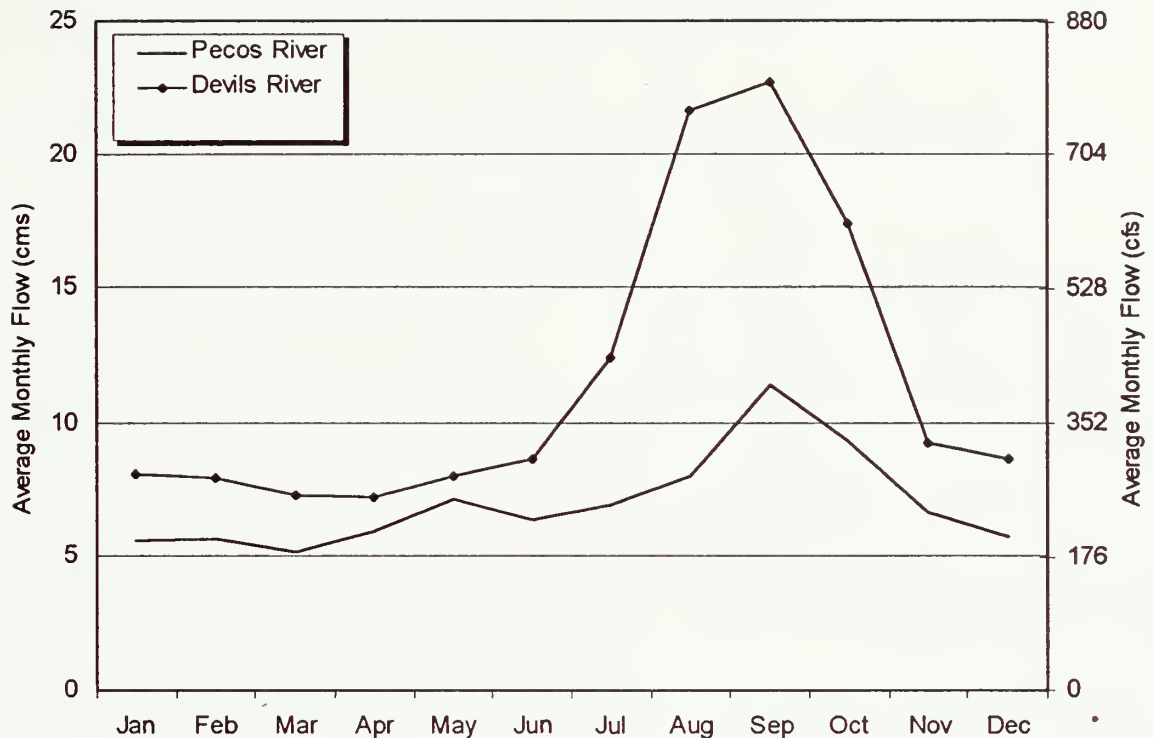
**Figure 11. Average Monthly Flow of Pecos and Devils Rivers (1968-1999).**

Base flows, originating from springs, average from 106 to 247 cfs (3 to 7 cms). Unlike the other inflows to Amistad Reservoir, base flows appear to be steady over the past 40 years. However, flows could decrease if groundwater use increases in this watershed.

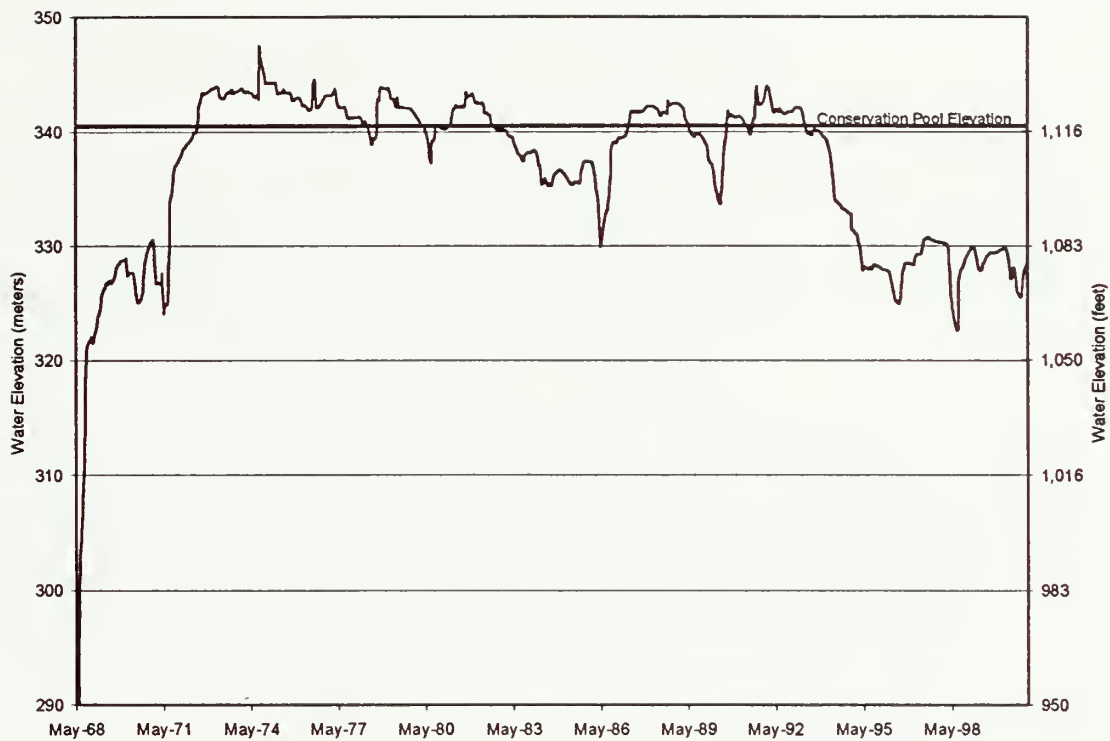
**Figure 13. Water Level Elevation of Amistad Reservoir.**

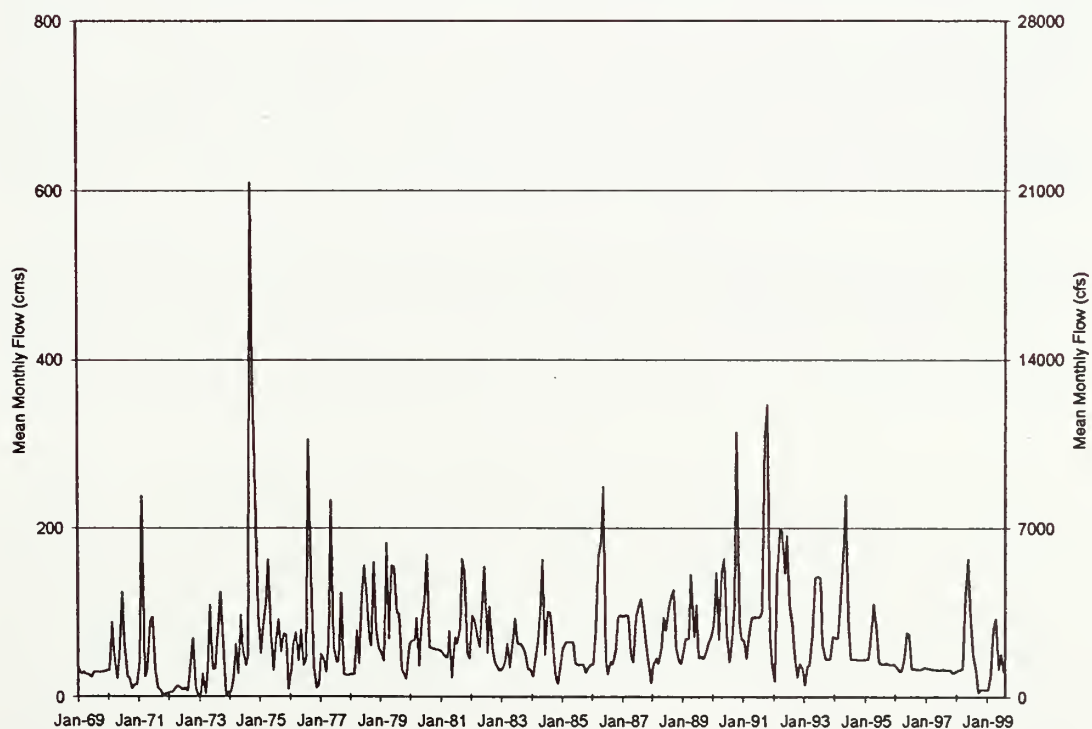
**Figure 14. Average Monthly Outflow from Amistad Dam (in cms) from 1969 to Present**

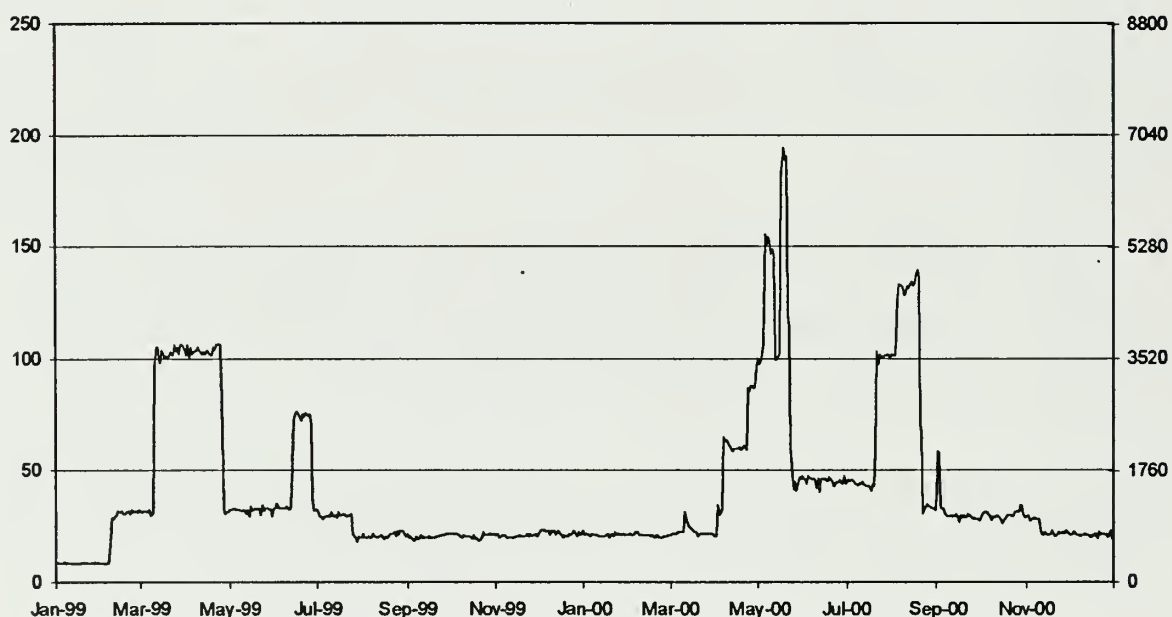
Figure 15. Average daily Amistad Dam Outflows (in cms) for 1990 through 1999.

Outflows through Amistad dam typically are highest during the irrigation season from spring through early summer. The largest flood since the reservoir was completed occurred in September 1974. Several other smaller floods occurred in the late 1970's and the early 1990's (Figure 14). A 1998 tropical storm caused flooding in San Felipe Creek, which flows into the Rio Grande near the town of Del Rio. Reservoir releases have decreased significantly since 1994 due to the decreased flow from the Rio Grande. Figure 15 illustrates the abruptness of the water releases. This unnatural hydrograph is undoubtedly affecting the riparian area directly below Amistad Dam. The abrupt increase and decrease of flow will tend to inhibit the formation and maintenance of channel point bars and riparian areas, and so decreases the aquatic and riparian habitat in this section of the Rio Grande.

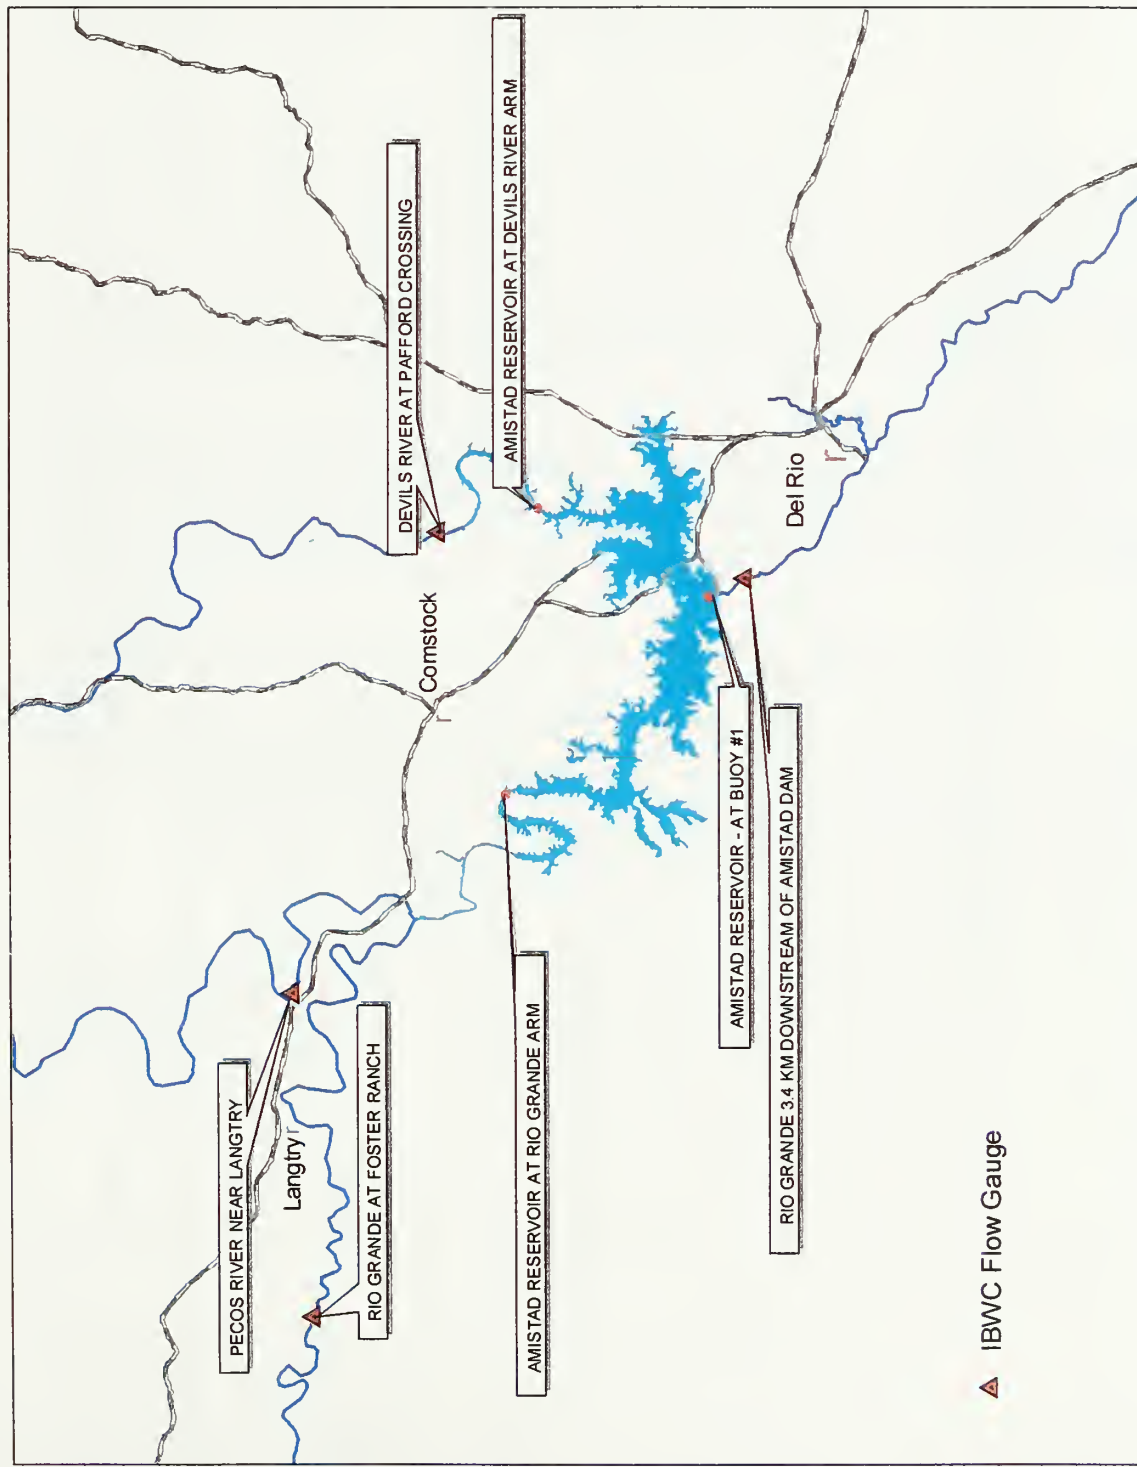
Figure 16. Map of Water Quality and Stream Flow Gauging Stations in the Amistad Area.

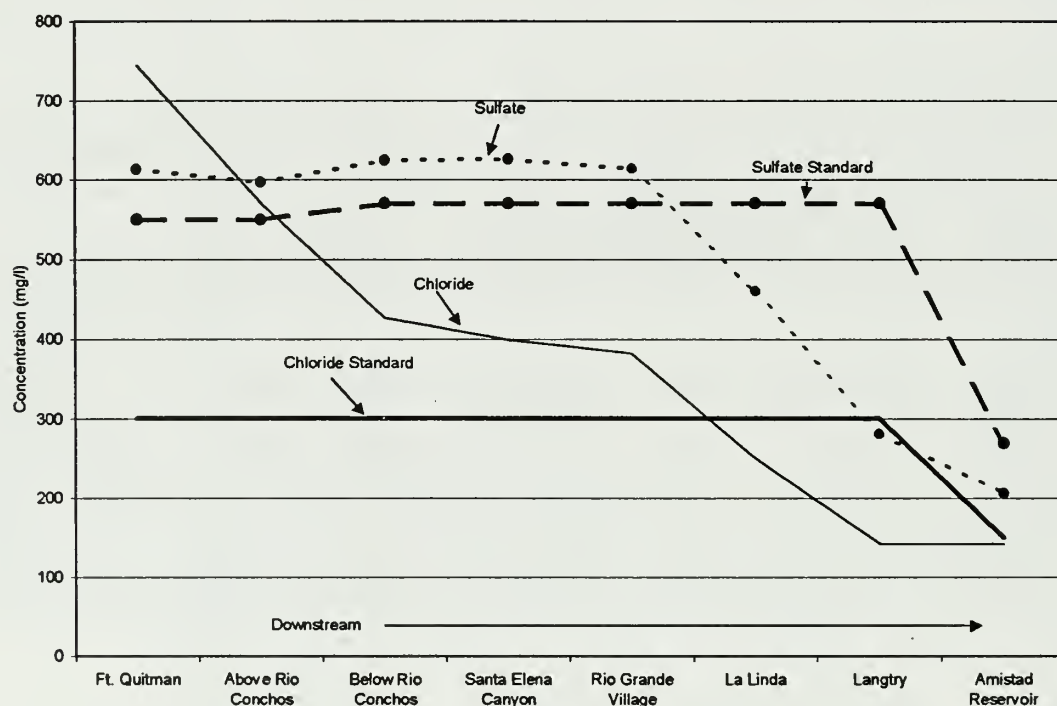
**Figure 17. Average Sulfate and Chloride Concentrations (1995-2000) for the Rio Grande Above Amistad. (IBWC, 2001)**

As mentioned above, water in this section of the Rio Grande originates both from the Upper Rio Grande (Segments 2307 and 2306) and the Rio Conchos. The river flows through deep canyons and the sparsely populated area along the border with Mexico. Water quality in this part of the Rio Grande reflects the quality of the water from these two rivers. However, historical mine tailings (primarily mercury, silver and lead) are located in the headwaters of several of the tributaries into the Rio Grande above Amistad. When these tributaries flow in response to a rainstorm, heavy metals and other toxins could be washed into the river.

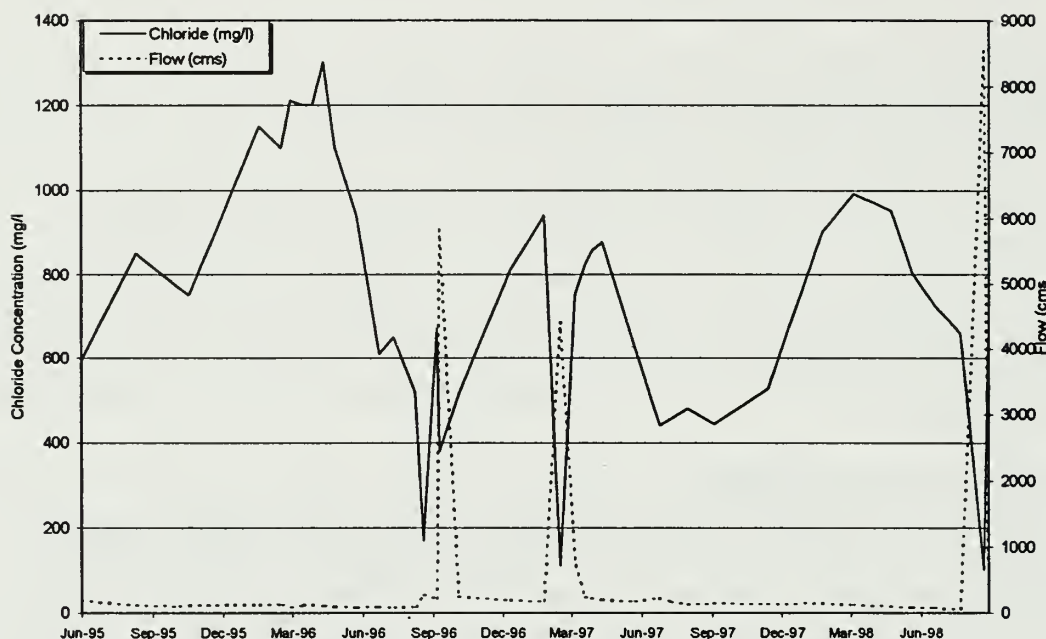
**Figure 18. Chloride Concentrations and Streamflow in the Pecos River at Langtry.**  
(from IBWC, 2001)

The 1992 and 1994 water quality assessments by TNRCC identified additional parameters of concern: mercury, silver selenium, and 2,4,5-T. Of these compounds, only mercury appears in the analysis of sediment and fish tissue (TNRCC, 1994a); (Texas Water Commission, 1992).

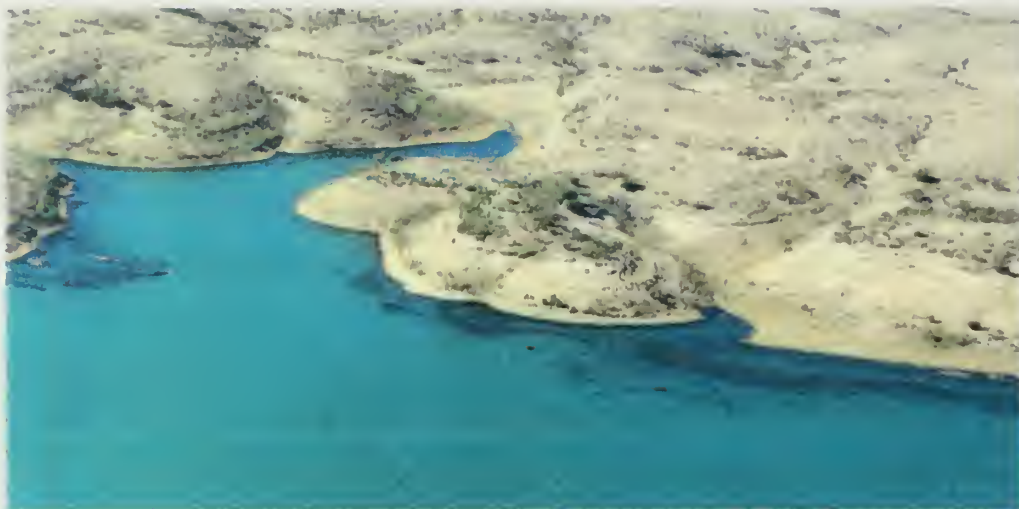
**Figure 19. Hydrilla Mats Along the Lakeshore**

Observed from a boat on Amistad reservoir, hydrilla tends to form in small to large mats (up to 100 feet (32 m) across) that are difficult to see. Under some lighting and wave size conditions the mats are nearly invisible. From the air, the mats are readily discerned as dark green to black areas on the water throughout the main portion of the reservoir and its side inlets. Larger hydrilla mats have been most common when water levels remain stable or dropping for extended periods of time. The conditions under which hydrilla appears to be less of an impact on visitors or boaters has been on rising water levels that keep ahead of hydrilla's growth. Naturally, vegetative growth does eventually catch up with such water level changes; thus the relief is only temporary.

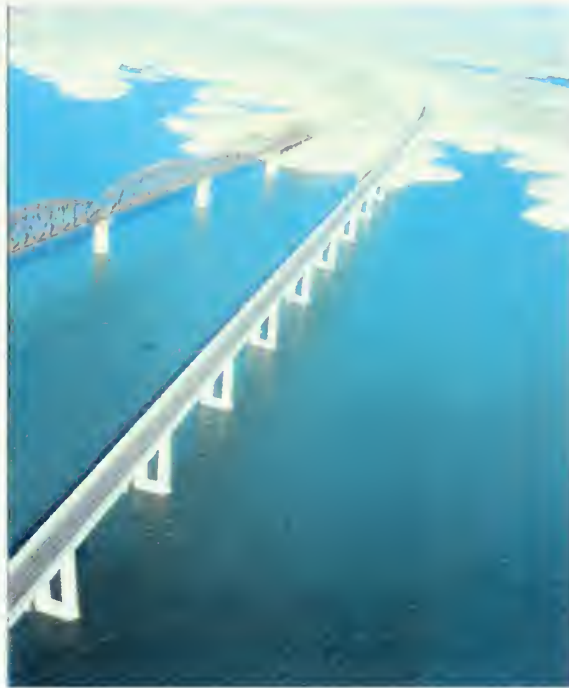
**Figure 22. Railroad and Hwy 90 Bridges Crossing Amistad Reservoir**

There is potential for both petroleum and hazardous material spills in the vicinity of the International Amistad Reservoir. US 90, a major east-west thoroughfare, parallels the reservoir along most of its length, crossing the reservoir at three locations: Governor's Landing, Evans Creek, and the Pecos River Arm. The Union Pacific Railroad also has a major rail line which generally parallels US 90 crossing the reservoir at both Governor's Landing and at the Pecos High Bridge (Figure 22). US 277/377, a north-south artery connecting Mexico with Interstate 10 crosses the reservoir via a bridge in the vicinity of San Pedro Canyon. A major petroleum or hazardous materials spill at any of these crossings or along drainages tributary to the reservoir has potential to adversely affect the waters within Amistad NRA. Response to third-party spills at these locations would likely come from Val Verde County Emergency Services, the Texas Highway Patrol, the TNRCC, and/or the Union Pacific Railroad.
